Medical Devices: The Therac-25*

Nancy Leveson
University of Washington

1 Introduction

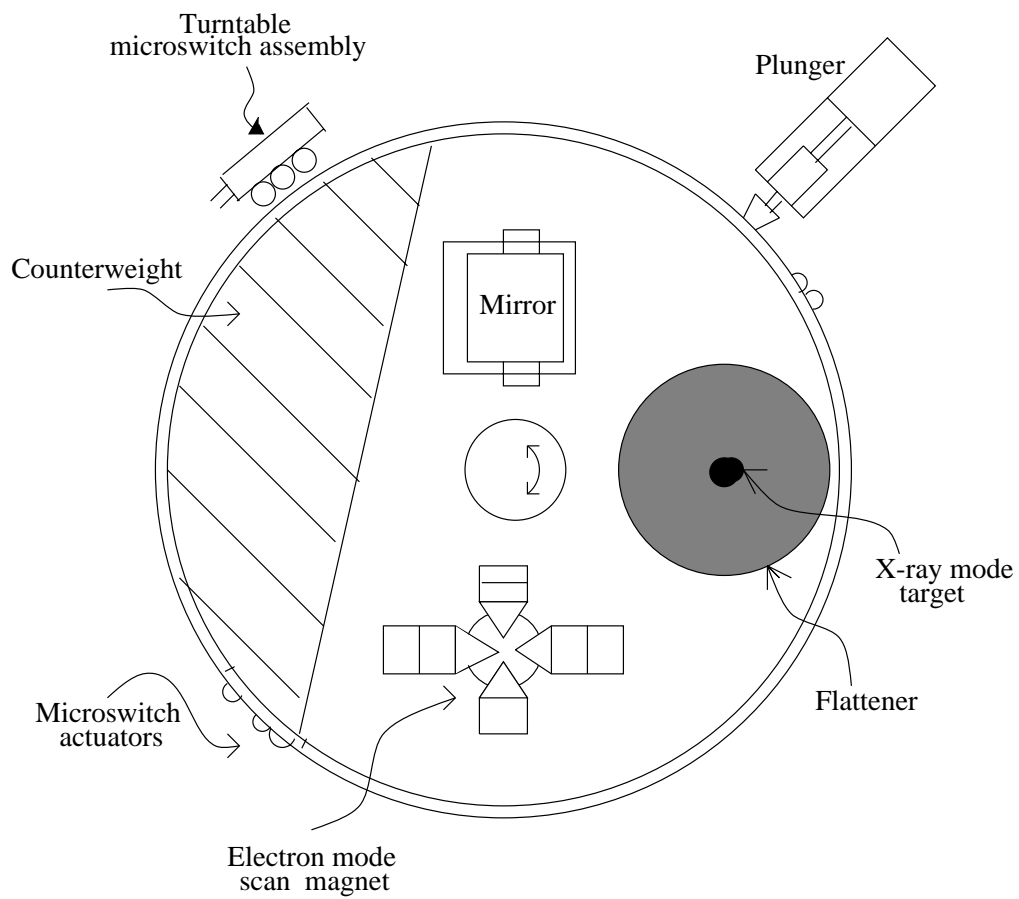
Figure 1: Upper turntable assembly.

Turntable Positioning. The Therac-25 turntable design plays an important role in the accidents. The upper turntable (see Figure 1) rotates accessory equipment into the beam path to produce two therapeutic modes: electron mode and photon mode. A third position (called the field light position) involves no beam at all, but rather is used to facilitate correct positioning of the patient. Because the accessories appropriate to each mode

are physically attached to the turntable, proper operation of the Therac-25 is heavily dependent on the turntable position, which is monitored by three microswitches.

The computer senses and controls turntable position by reading a 3-bit signal about the status of three microswitches in the turntable switch assembly. Essentially, AECL determined that a 1-bit error in the microswitch codes (which could be caused by a single open-circuit fault on the switch lines) could produce an ambiguous position message to the computer. The problem was exacerbated by the design of the mechanism that extends a plunger to lock the turntable when it is in one of the three cardinal positions: The plunger could be extended when the turntable was way out of position, thus giving a second false position indication. AECL devised a method to indicate turntable position that tolerated a 1-bit error so that the code would still unambiguously reveal correct position with any one microswitch failure.

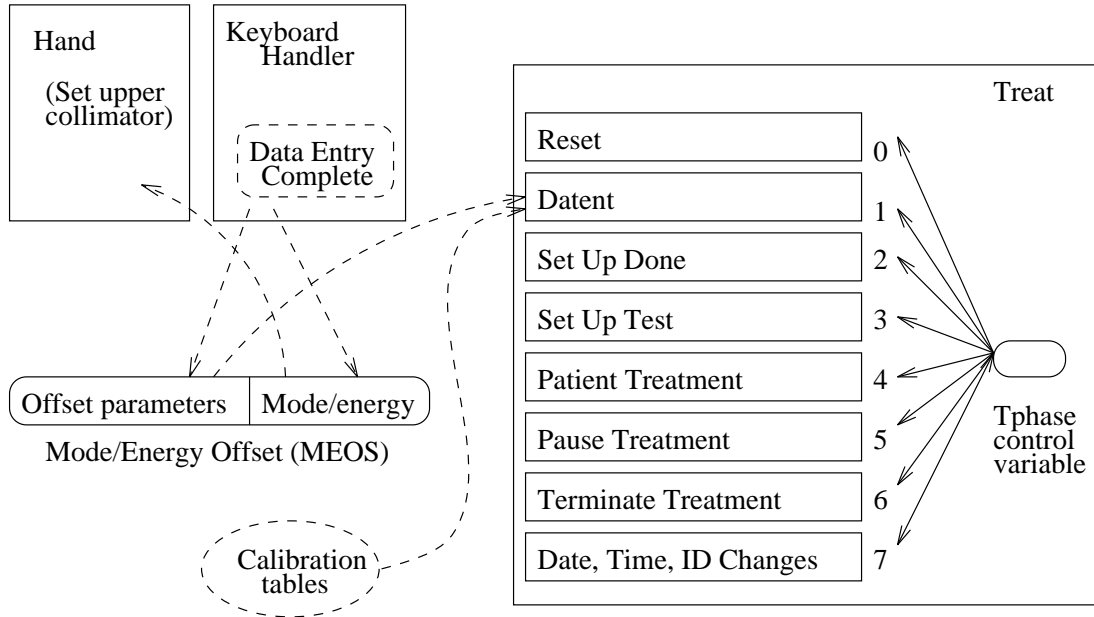
Figure 3: Tasks and subroutines in the code blamed for the Tyler accidents.

The treatment monitor task (Treat) controls the various phases of treatment by executing its eight subroutines. The treatment phase indicator variable (Tphase) is used to determine which subroutine should be executed (Figure 3). Following the execution of a particular subroutine, Treat reschedules itself.

But this is not the only problem. Upon exit from the Magnet subroutine, the data entry subroutine (Datent) checks the Data Entry Complete variable. If it indicates that data entry is complete, Datent sets Tphase to 3 and Datent is not entered again. If it is not set, Datent leaves Tphase unchanged, which means it will eventually be rescheduled. But the Data Entry Complete variable only indicates that the cursor has been down to the command line, not that it is still there. A potential race condition is set up. To fix this, AECL introduced another shared variable controlled by the keyboard handler task that indicates the cursor is not positioned on the command line. If this variable is set, then prescription entry is still in progress and the value of Tphase is left unchanged.

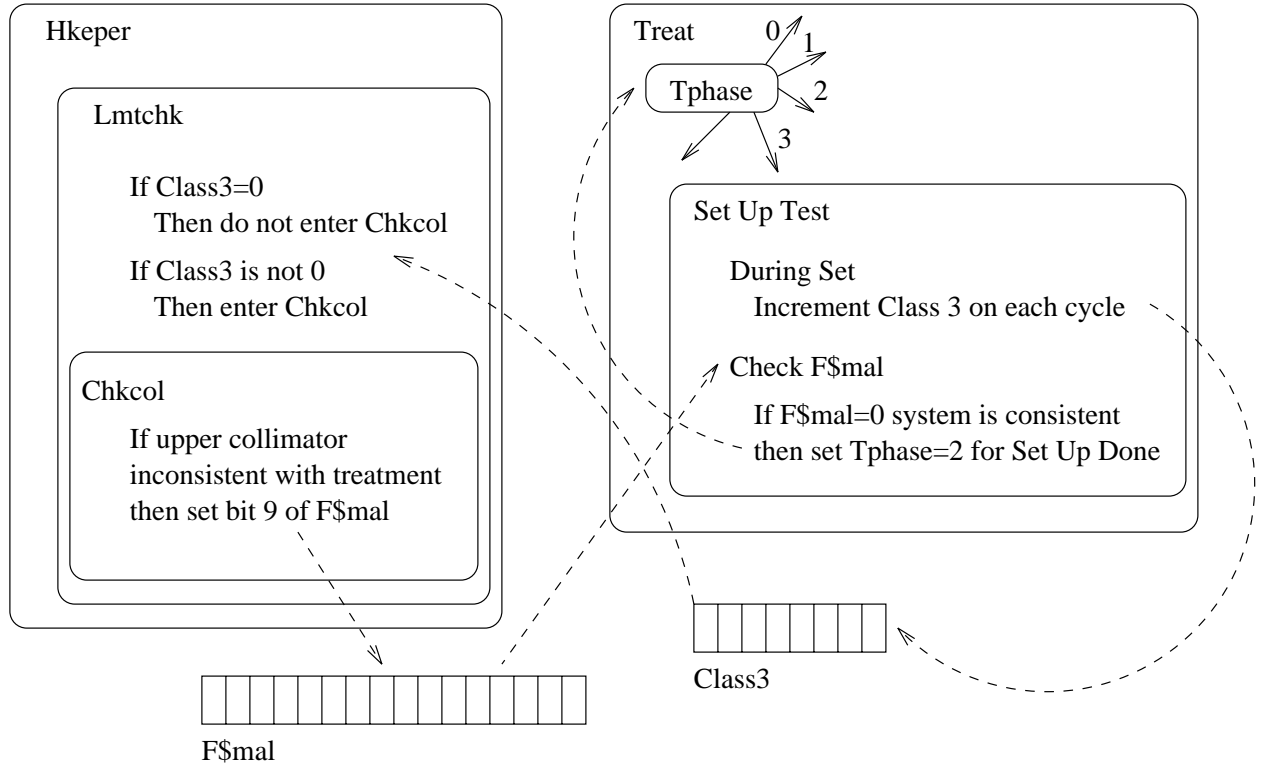
Figure 4: The Yakima software flaw.

The second Yakima accident was again attributed to a type of race condition in the software — this one allowed the device to be activated in an error setting (a “failure” of a software interlock). The Tyler accidents were related to problems in the data-entry routines that allowed the code to proceed to Set Up Test before the full prescription had been entered and acted upon. The Yakima accident involved problems encountered later in the logic after the treatment monitor Treat reaches Set Up Test.

The overexposure occurred when the operator hit the “set” button at the precise moment that Class3 rolled over to zero. Thus, Chkcol was not executed and F\$mal was not set to indicate that the upper collimator was still in the field-light position. The software turned on the full 25 MeV without the target in place and without scanning. A highly concentrated electron beam resulted, which was scattered and deflected by the stainless
