Medical Devices: The Therac-25*

Nancy Leveson
University of Washington

1 Introduction

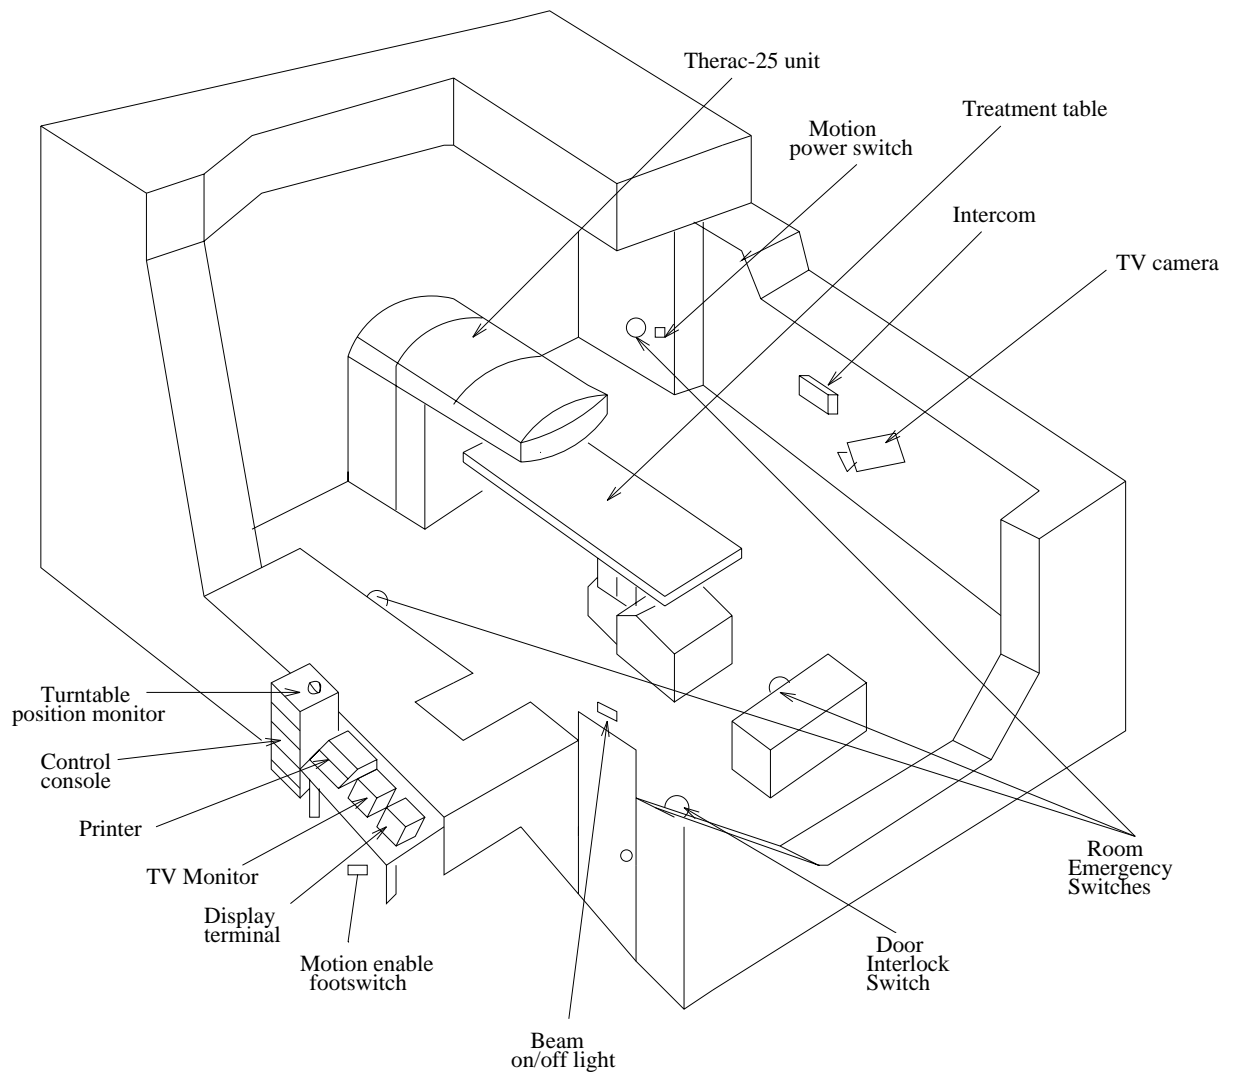
Figure 5 shows a typical Therac-25 installation after the CAP changes were made.

Figure 5: A typical Therac-25 facility after the final CAP.

- Beam-on will be prevented if the turntable is in the field light or any intermediate position.
- Cryptic malfunction messages will be replaced with meaningful messages and highlighted dose-rate messages.

- The known software problems associated with the Tyler and Yakima accidents will be fixed.
- The manuals will be fixed to reflect the changes.
